› AUTOMATED RAVELING INSPECTION AND MAINTENANCE PLANNING ON POROUS ASPHALT IN THE NETHERLANDS

FIRM15 - Brussels

Willem van Aalst - TNO
Giljam Derksen
Peter-Paul Schackmann

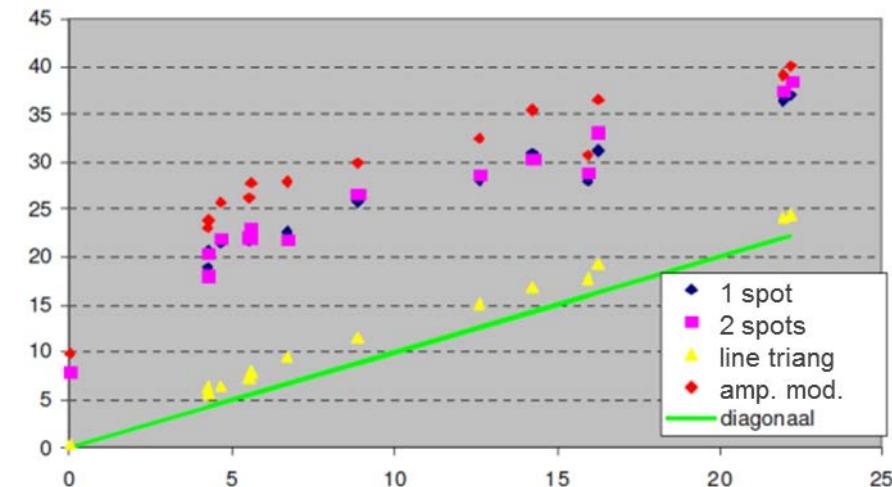
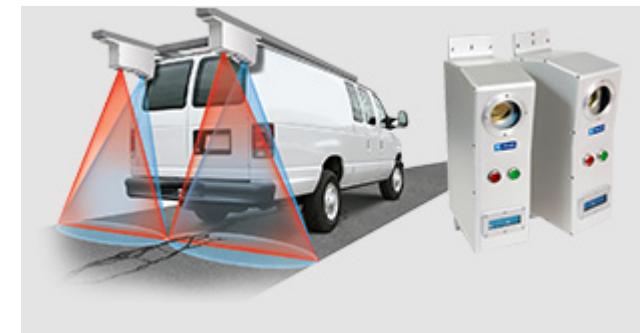
LCMS system

- › Simulation of measurement systems
- › State of the art systems:
 - › Laser triangulation (1 or 2 spots)
 - › Laser triangulation (2 lines)
 - › Amplitude phase modulation lasers
- › Selected: line laser triangulation
 - › LCMS sensors (INO/Pavometrics)

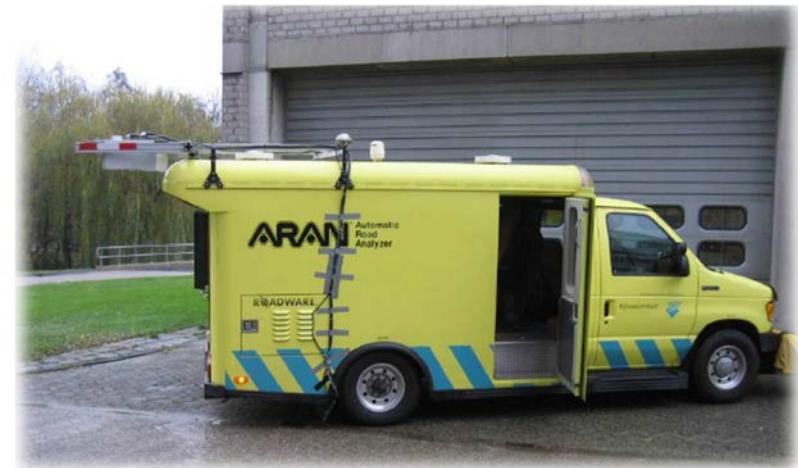
RWS ARAN 2 equipped with the LCMS system

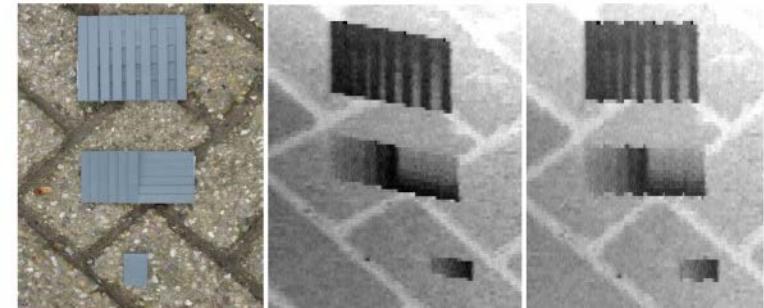
Test objects used to validate system specifications

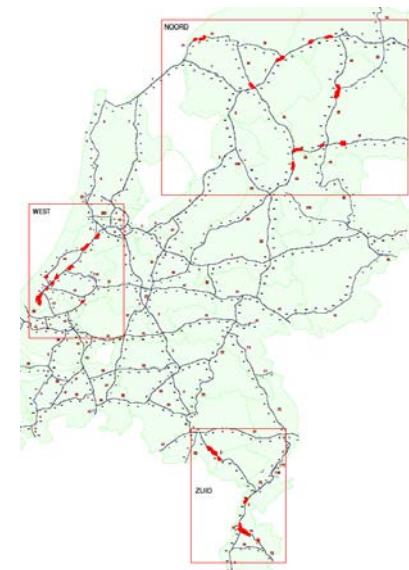
- › Visual versus Model:

- › Good correlation with visual inspections!
- › 93% (+/- 1 year)

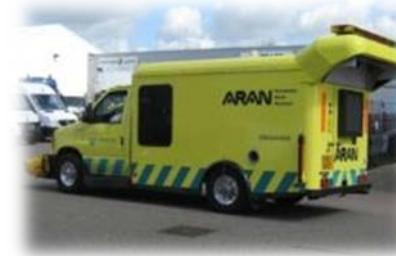
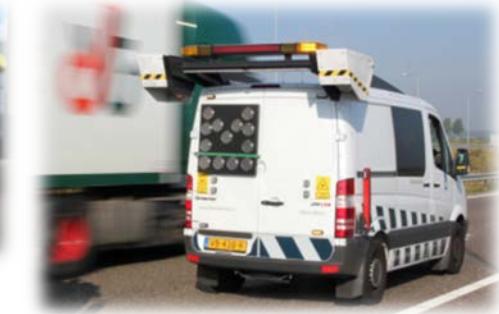
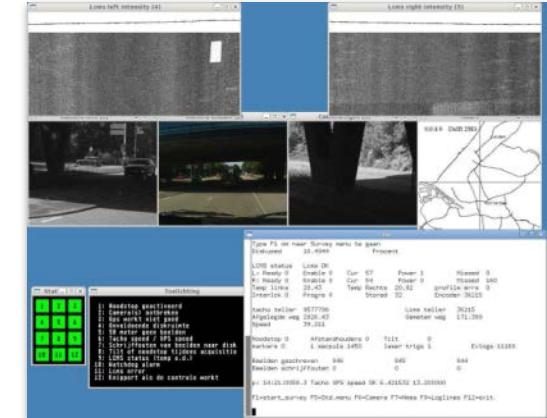
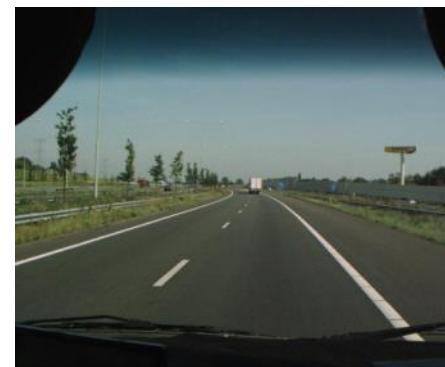
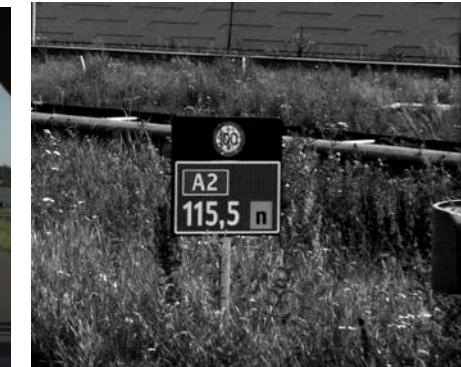
Main components

- › LCMS sensors & controller (3D data)
- › Laser Safety Controller (tilt, speed, ...)
- › RTK – GPS (positioning)
- › DMI (triggering)
- › Front- & side camera's (reference)
- › FPGA framegrabber (HW timing)
- › Acquisition pc (Windows)
- › Control pc (Unix)

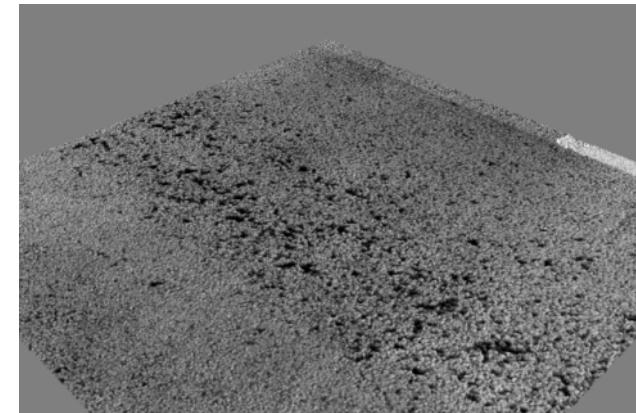
- › High speed 'in-traffic' measurements
 - › ~120 km/h
 - › Lane wide: 4 meters
- › 3D range data
- › 2D intensity data
- › Resolution:
 - › 1.0 mm (transversal)
 - › 4.7 mm (longitudinal)
- › Accuracy (height):
 - › ~ 0.5 mm (σ)

2 x 2 m section

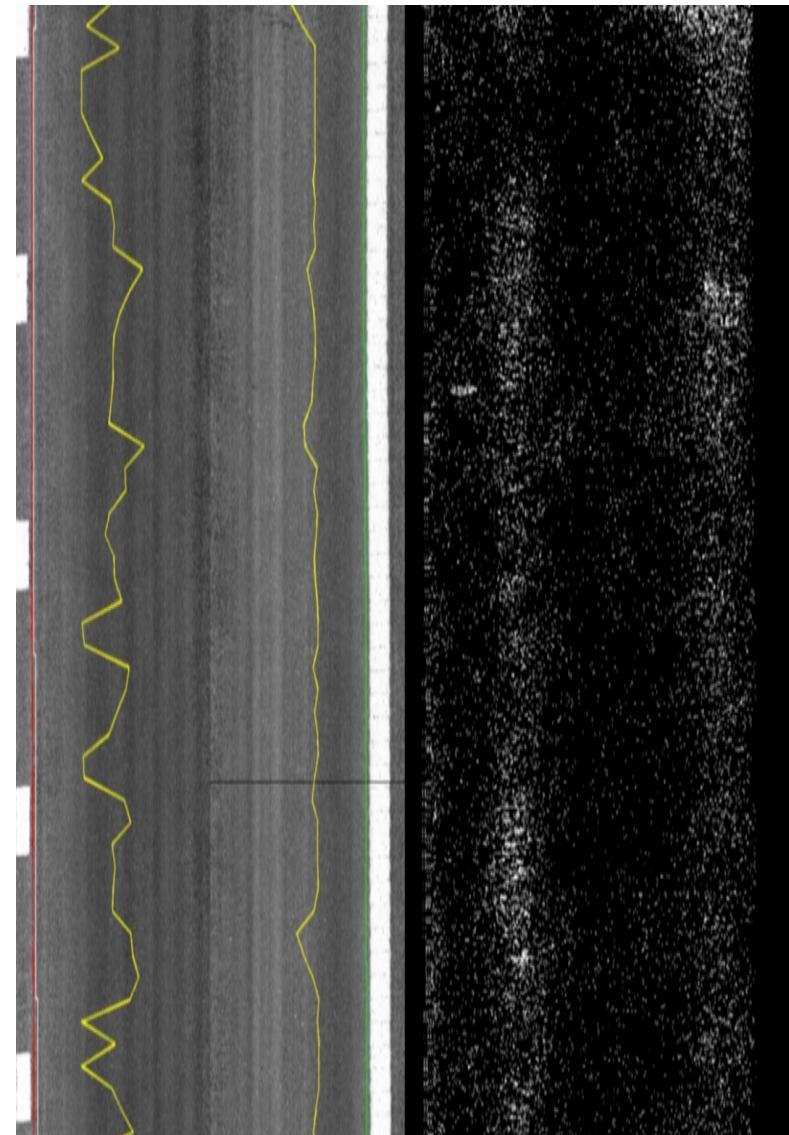
1. Road-marking detection
2. Flattening (road & vehicle motion)
3. **Texture analysis** (pavement type)
4. Removal of:
 - Mechanical damage (rim marks)
 - Joints
5. Wheel path (maximum damage)
6. **Raveling (per m² in wheel path)**
 - **% stone loss**
 - **% clustered stone loss**

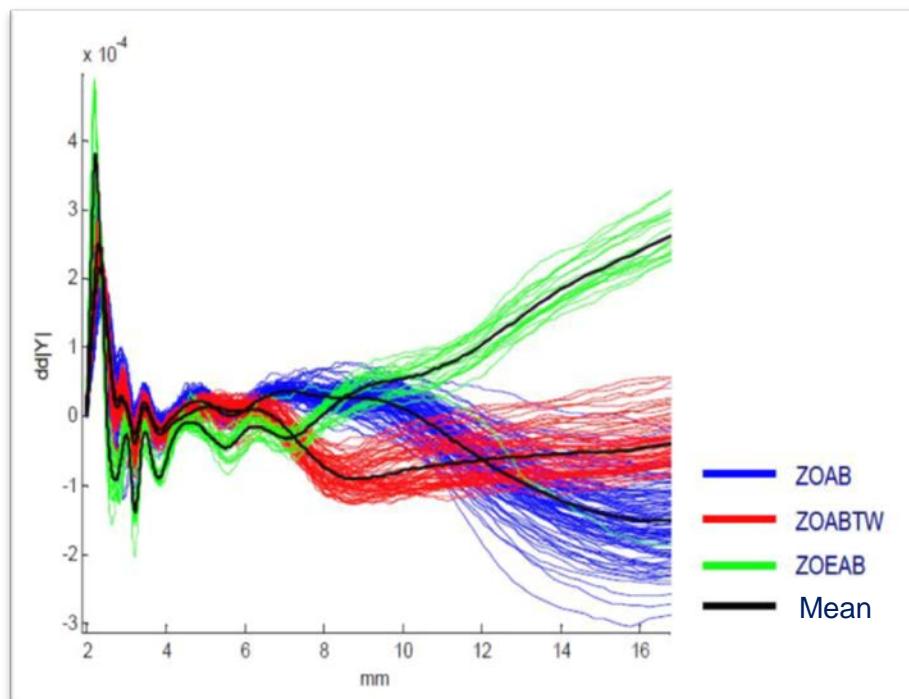
Spectrum analysis

- › Dependencies on pavement type
 - › Raveling
 - › Maintenance interval
- › Two approaches:
 - › Spectrum based (FFT)
 - › Texture based (various descriptors)

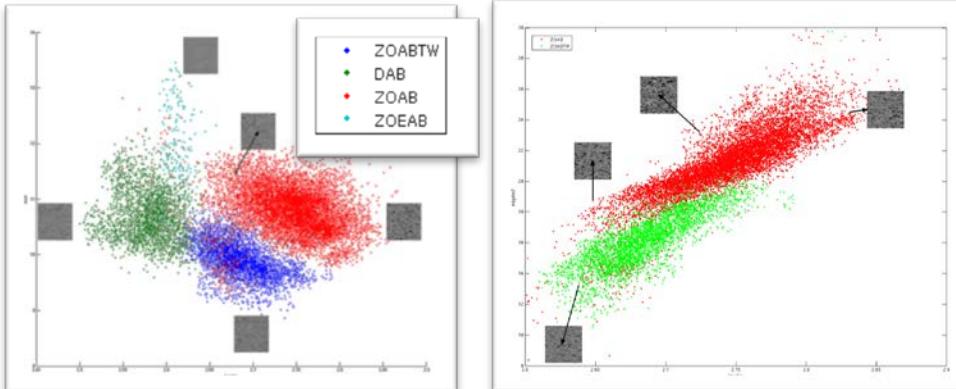
- › Classification
 - › 11 texture measures
 - › Quadratic classifier
- › Evaluation set
 - › N = 27.128 (100m)

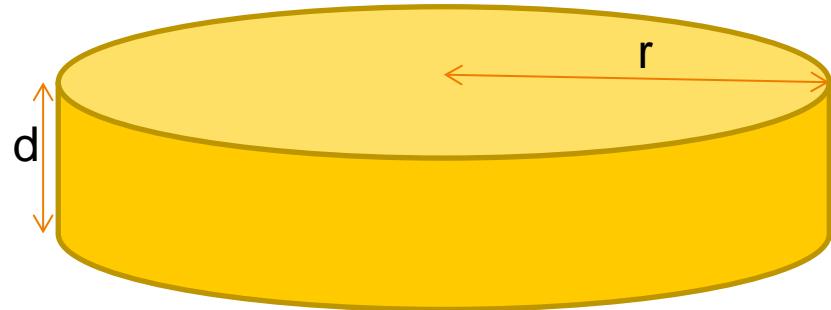
- › Flatten & clean data
- › ‘Coin’ algorithm
 - › Radius (r)
 - › Depth (d)

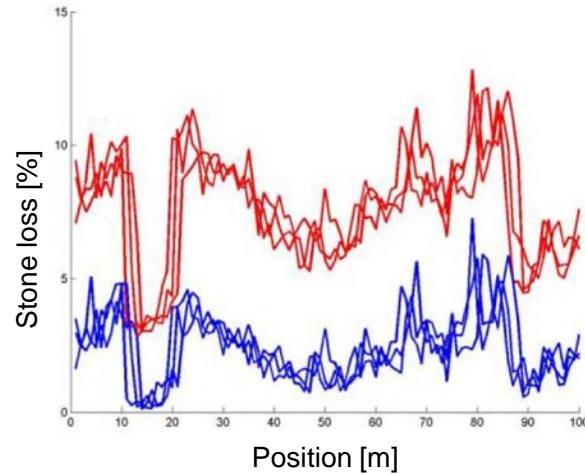
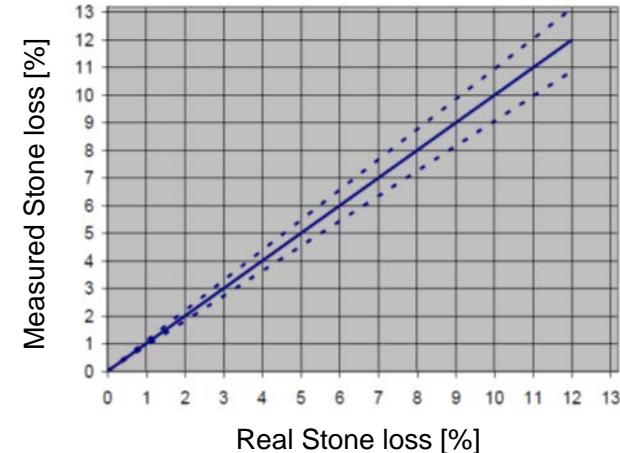
- › Repeatability:
 - › Very good!

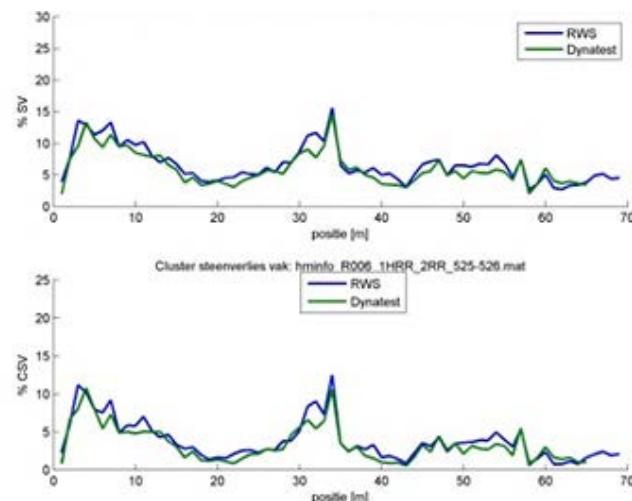
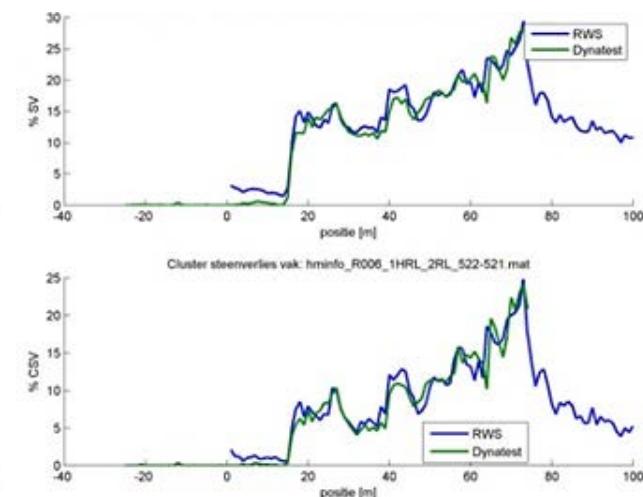
- › Reproducibility:
 - › Very good!

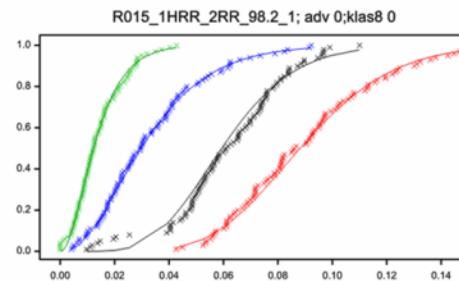
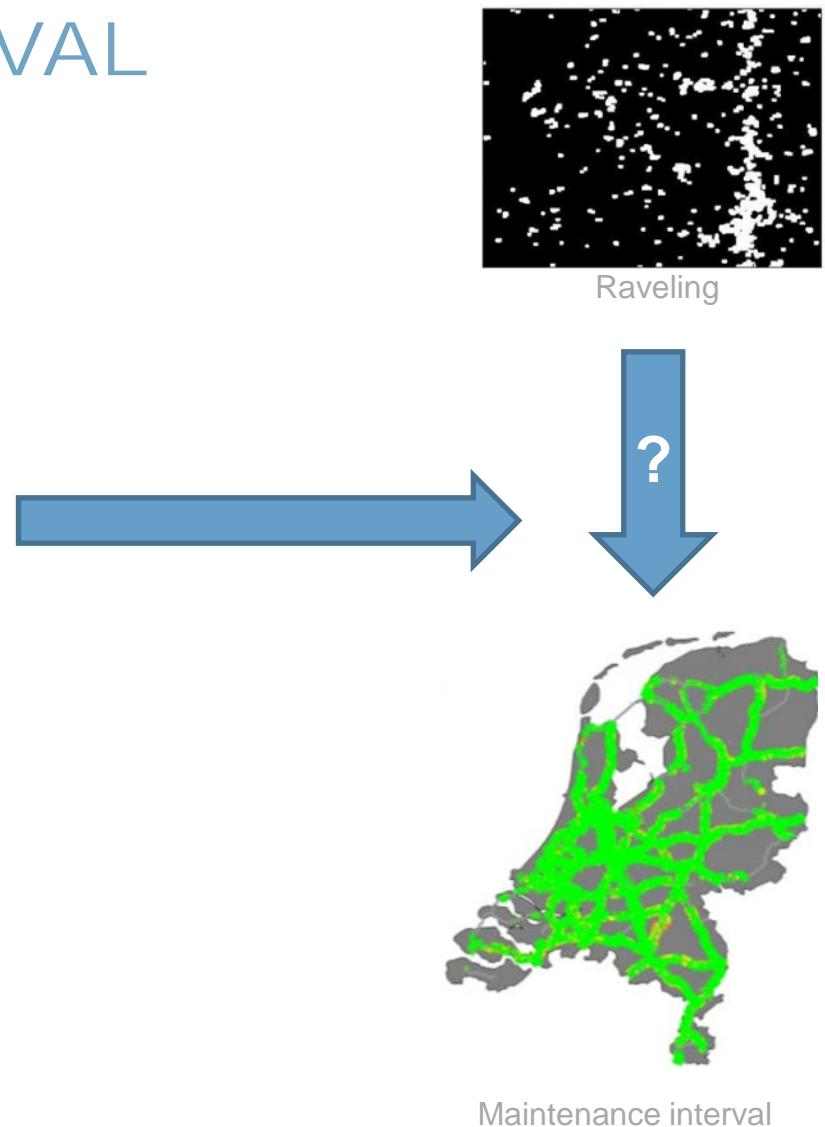
- › Input:
 - › Ravelling per m² (both wheel paths)
- › Linear classifier
 - › 28 inputs → 1 output (per 100m)
 - › Trained on visual inspections

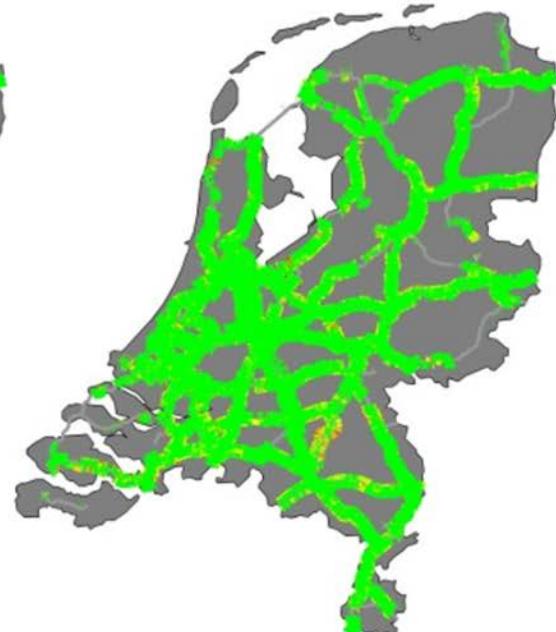
- › Results:
- › 2014
